**DEPARTMENT OF TRANSPORTATION**

Contract #: 04-0120F4Cty: SF/ALA Rte: 80 PM: 13.2/13.9File #: 1.28**WELDING INSPECTION REPORT****Resident Engineer:**Siegenthaler, Peter**Address:** 333 Burma Road**City:** Oakland, CA 94607**Report No:** WIR-025899**Date Inspected:** 08-Aug-2011**Project Name:** SAS Superstructure**OSM Arrival Time:** 700**Prime Contractor:** American Bridge/Fluor Enterprises, a JV**OSM Departure Time:** 1530**Contractor:** American Bridge/Fluor Enterprises, a JV**Location:** Jobsite**CWI Name:** John Pagliero**CWI Present:** Yes No**Inspected CWI report:** Yes No N/A**Rod Oven in Use:** Yes No N/A**Electrode to specification:** Yes No N/A**Weld Procedures Followed:** Yes No N/A**Qualified Welders:** Yes No N/A**Verified Joint Fit-up:** Yes No N/A**Approved Drawings:** Yes No N/A**Approved WPS:** Yes No N/A**Delayed / Cancelled:** Yes No N/A**Bridge No:** 34-0006**Component:** SAS OBG**Summary of Items Observed:**

## WELDING INSPECTION REPORT

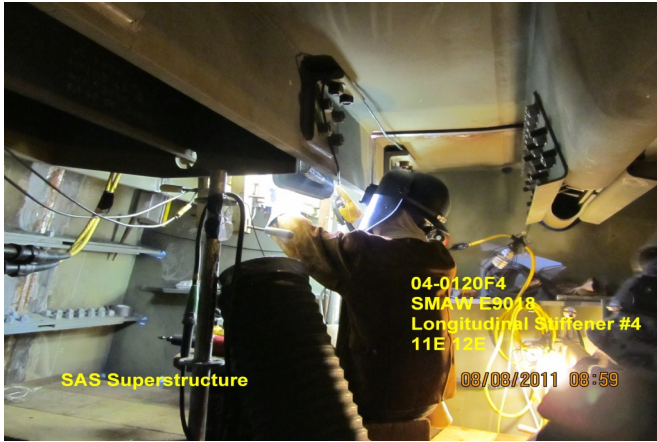
### 3. 11E 12E North Side (Interior)

The QA inspector observed ABF welder Hua Qiang Hwang ID#2930 performing Shielded Metal Arc Welding (SMAW) in the 3G vertical position on Longitudinal Stiffener (LS)#4 located at 11E 12E in the interior of the OBG. The QA inspector noted the use of an electrode oven at the required temperature for the E9018-MH4-R electrodes. The QA inspector observed the QC inspector identified as Fred Von Hoff monitoring the progress to ensure the welding parameters were in compliance pertaining to ABF-WPS-D15-1012-3. The parameters were recorded as (Amperes=135).

Upon completion of the south face of the joint, the heat induction blankets were implemented on the completed weld and the welder commenced welding on the north face of the joint. The QA inspector made subsequent observations throughout the shift to monitor quality and noted that the work was completed on this date and appeared to be in general conformance with the contract documents. (see photo below)

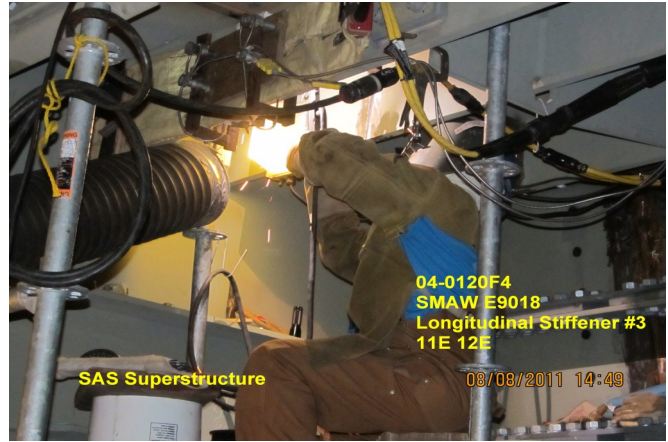
### 4. 11E 12E South Side (Interior)

The QA inspector observed ABF welder Xiao Jian Wan ID#9677 performing Shielded Metal Arc Welding (SMAW) in the 3G vertical position on Longitudinal Stiffener (LS)#3 located at 11E 12E in the interior of the OBG. The QA inspector noted the use of an electrode oven at the required temperature for the E9018-MH4-R electrodes. The QA inspector observed the QC inspector identified as Fred Von Hoff monitoring the progress to ensure the welding parameters were in compliance pertaining to ABF-WPS-D15-1012-3. The parameters were recorded as (Amperes=132).

Upon completion of the north face of the joint, the induction heat blankets were implemented on the completed weld and the welder commenced welding on the south face of the joint. The QA inspector made subsequent observations throughout the shift to monitor quality and noted that the work was completed on this date and appeared to be in general conformance with the contract documents. (see photo below)
